SUBJECT: Summary Report and December 7, 2009 RAI, Item 2, Response
Suwannee American Cement – Branford, Suwannee County
DEP File No. 1210465-016-AC (PSD-FL-259G), Permit No. 121-465-017-AC
Alternative Fuel Materials Testing – SAC Cement Kiln

Trial Burn Summary Report

Suwannee American Cement, LLC
5117 US HWY 27, Branford, FL 32008
Permit No. 1210465-017-AC

1. Executive Summary

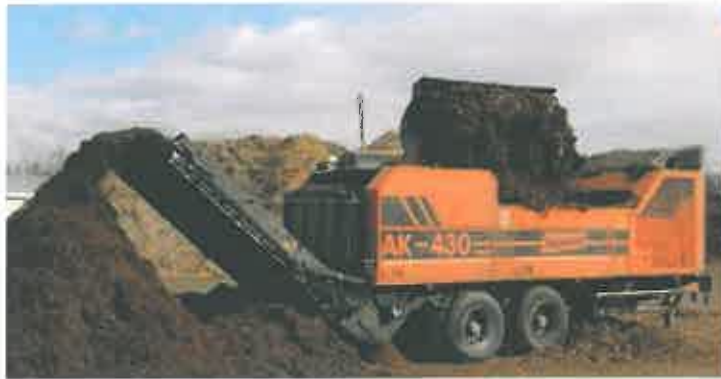
Figure 2.2 Image of a Doppstadt AK 430 in operation. The AK 630 is similar only larger.

screening system. SAC contracted with Peninsula Equipment (a.k.a. Blanchard CAT) to rent a model GRDAK630 Doppstadt diesel powered grinder and model SCRSM 720 Doppstadt diesel powered screen and magnet for the duration of the test trial. Typically this equipment is used for shredding of construction debris or wood waste, but has also been used for shredding solid waste. Based on preliminary batch tests, the expected re-processing rate of auto fluff with the rented equipment was 10 tons per hour.

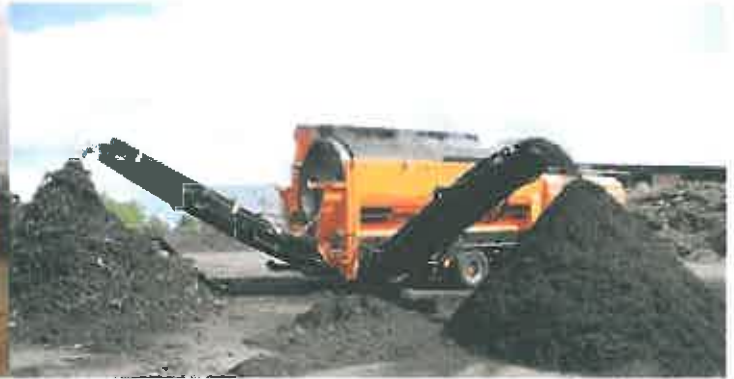
Figure 2.3 Image of a Doppstadt mobile screen in operation.

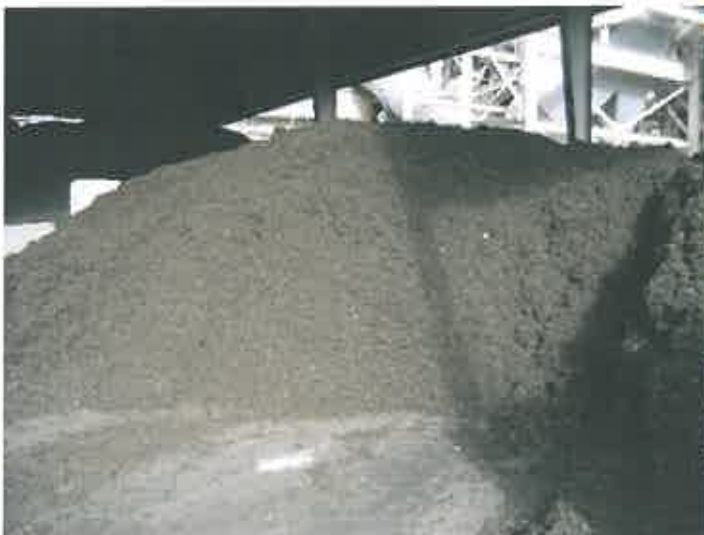
Figure 2.4 Image of a SAC's temporary covered storage area.

SAC received the material by covered truck and stored the material under cover in a portion of its coal storage building. From there the material was carried by front end loader to the Schenck dosing system on an as need basis. The live bottom hopper of the dosing system was capable of holding approximately 2 bucket loads of material.

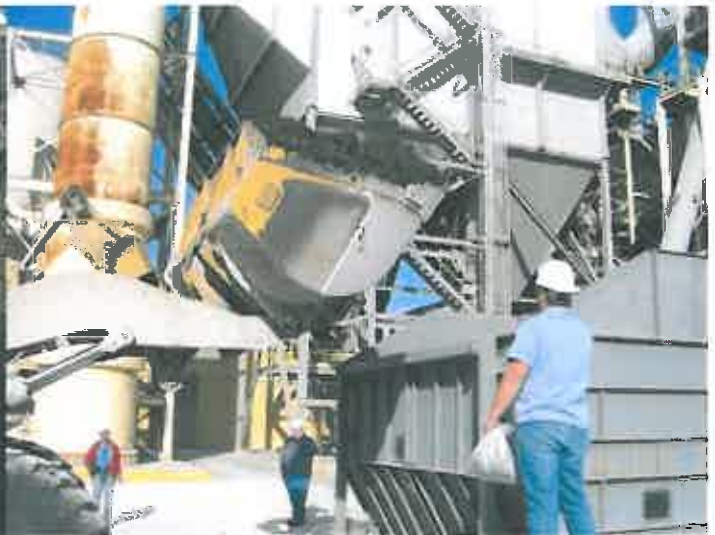
Figure 2.5 Experiment to remove metal (shows metal from one bucket load of material).

Very quickly it became apparent that the amount of metal existing in the auto fluff exceeded expectations. SAC expected approximately six percent metal (base on information from Gerdau), but it became evident that the concentration of metal in the source material was significantly higher. Shredder hammers were repeatedly damaged in the process of this discovery. Therefore it was determined that a magnet on the exit belt of the trommel was necessary to remove some of the metal prior to the shredder and that Gerdau would have to try to remove more metal in their shredding process. SAC decided to run some experiments to demonstrate the amount of metal being wasted in the auto fluff. One non-scientific experiment demonstrated that in one loader bucket of auto fluff there was an estimated 700 to 1000 lbs of metal, by rough estimates this is between 10 and 20 percent metal (see Figure 3.3. below).

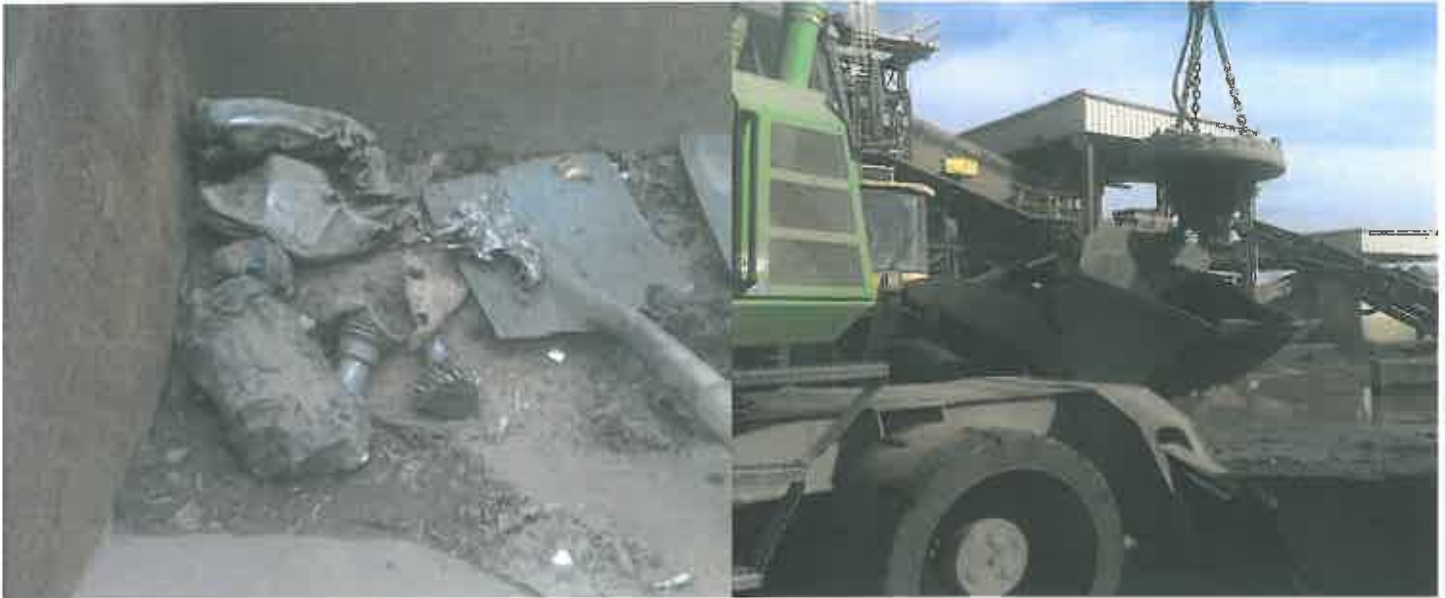
Figure 3.2 Examples of metal contamination present in the auto fluff. The shovel head is present for size comparison.

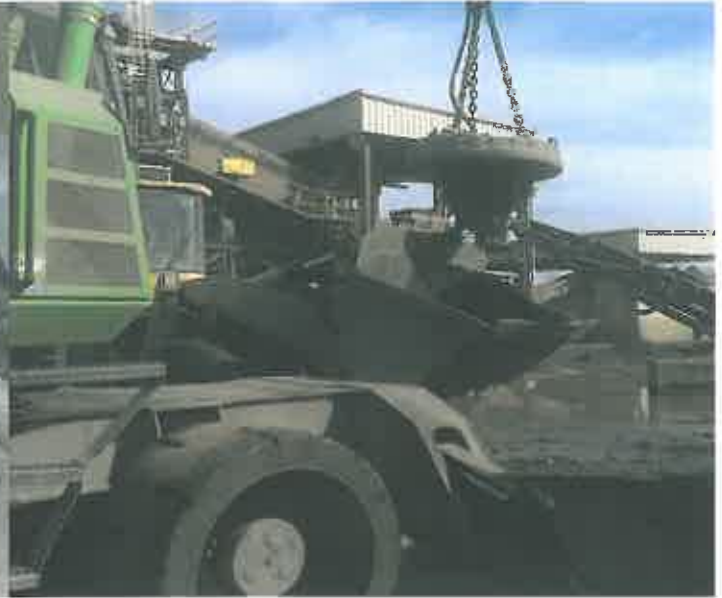
Figure 3.3 Experiment to remove metal (shows metal from one bucket load of material).

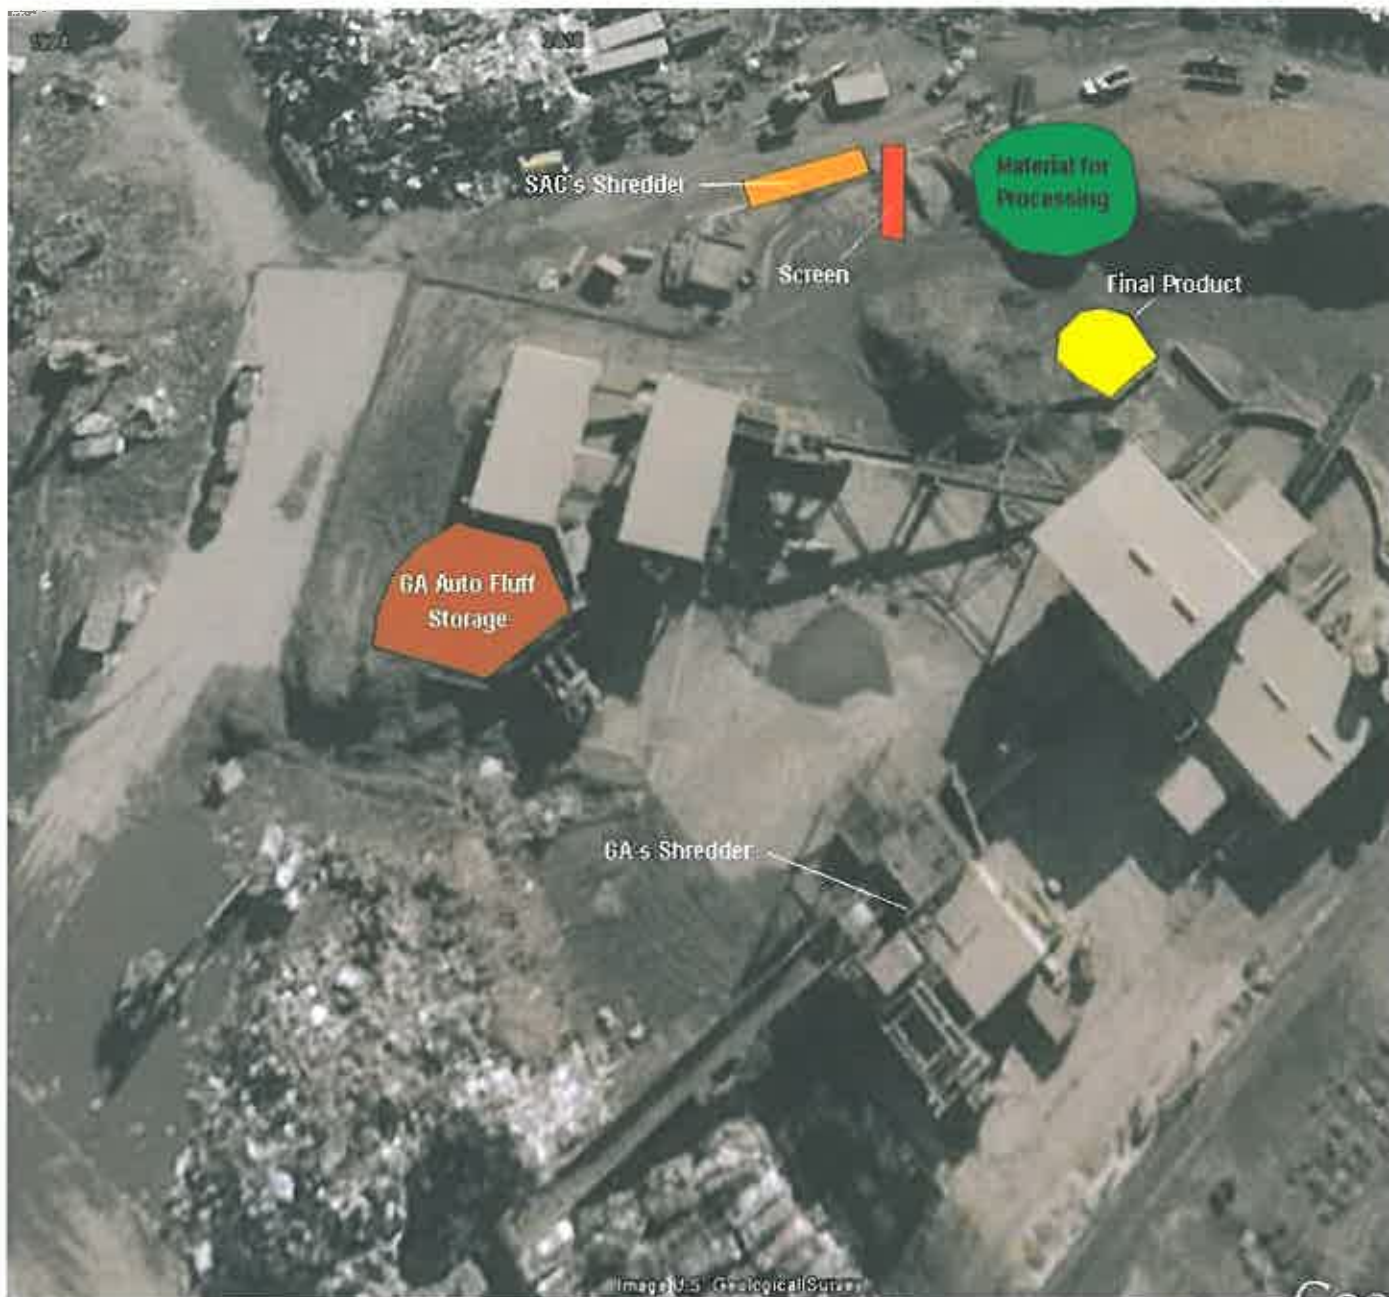
Figure 3.7 Aerial view of GA shredder operations with diagrams showing the location of SAC's re-shredding operations.

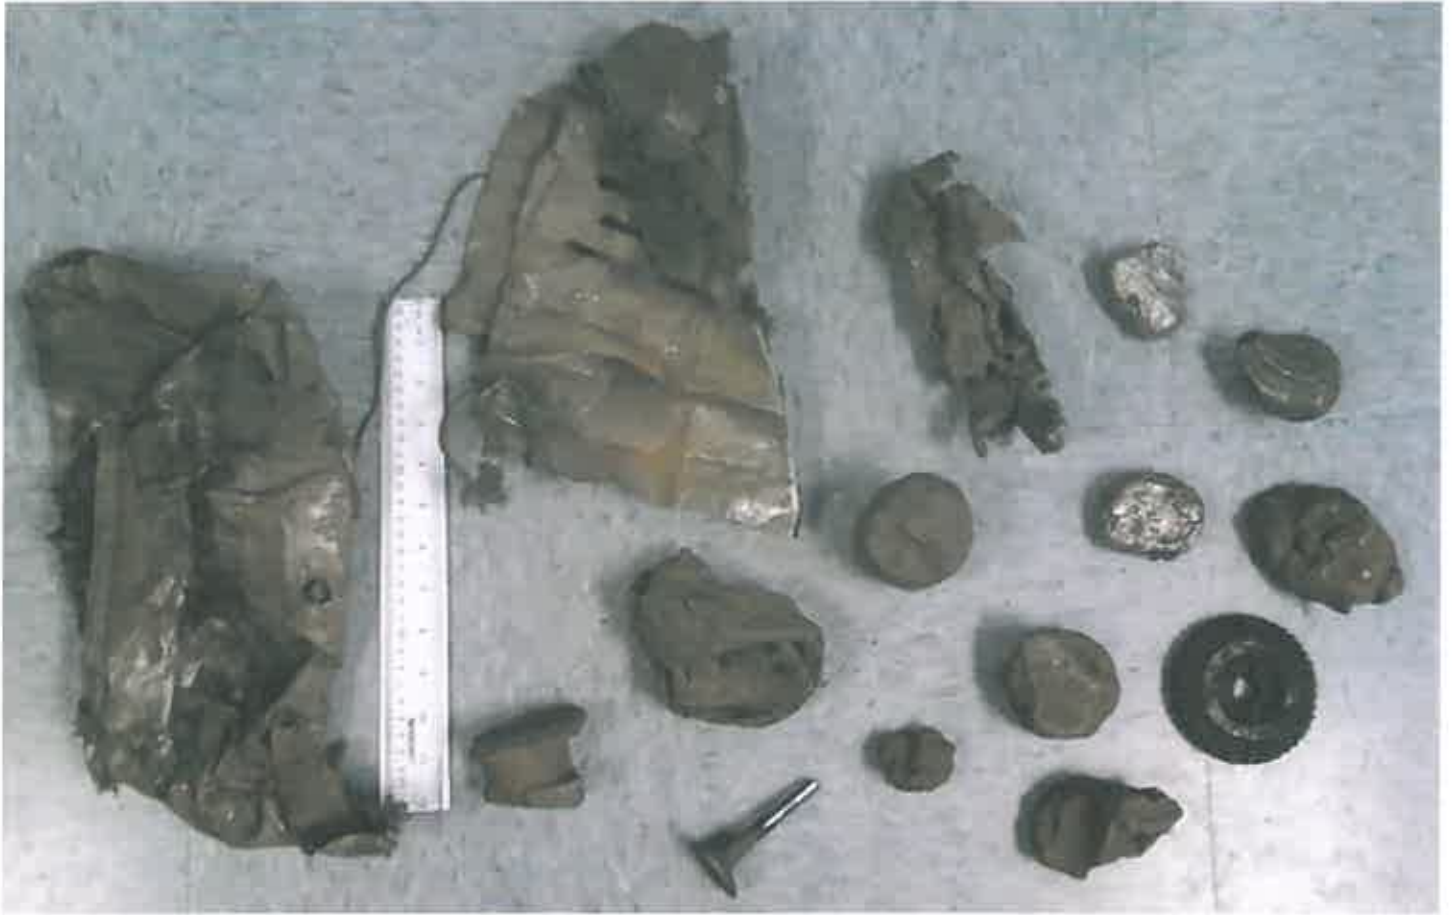
Figure 3.8 Example of pieces of metal pulled from the tripped feeding equipment. The 12 inch ruler is for reference of scale. It is not likely for any of these materials to have made it through the one inch trommel.

Metal contamination of material processed at Gerdau can be attributed to most of the stops of the SAC fuel feeding system during the test trial (see Figure 3.8 below). Likely sources for this contamination are related to SAC's final product storage area at the Baldwin facility and contamination during transportation. The re-processed auto fluff storage piles, at the Baldwin facility, were located next to a large pile of scrap metal. Since SAC's final product storage area was not in its own individual storage bay it is likely that pieces of metal could have rolled down off the scrap metal pile into SAC's storage area. Also the auto fluff was being handled by front loader and delivery trucks that haul unprocessed auto fluff for Gerdau. It is likely that there could have been some pieces of metal and debris left in the buckets or beds of these transport vehicles.

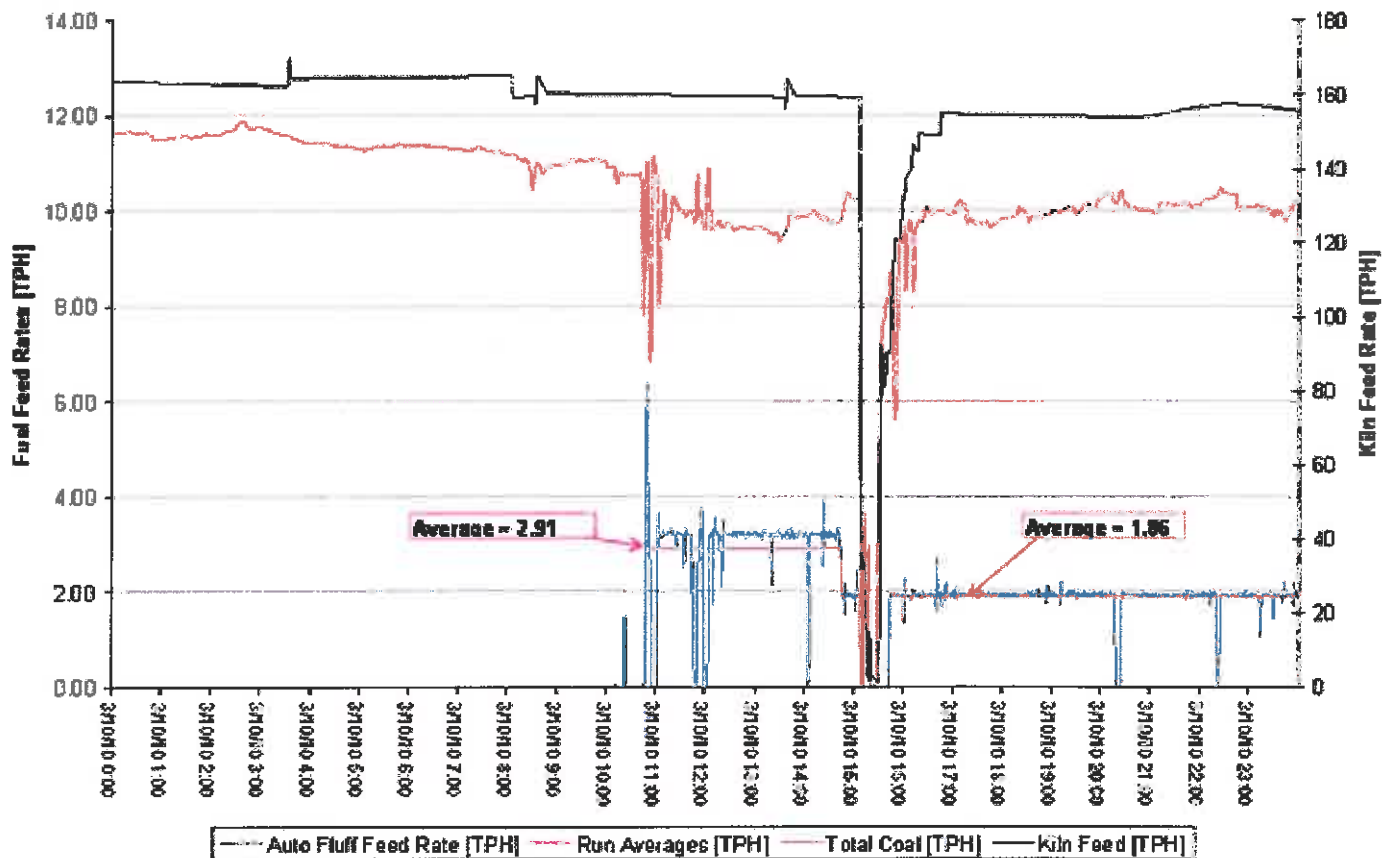
Chart 4.1 March 10, 2010 kiln feed rate, coal feed rate, and auto fluff feed rate.

Immediately after starting, the feeding system tripped. There were some problems with the electric motors that drive the screws of the auto fluff live bottom feeder. SAC was targeting 1 TPH, but this low tonnage caused too much torque on the motor and it kept overloading. Therefore, a higher feed rate near 2 TPH was targeted for start up.

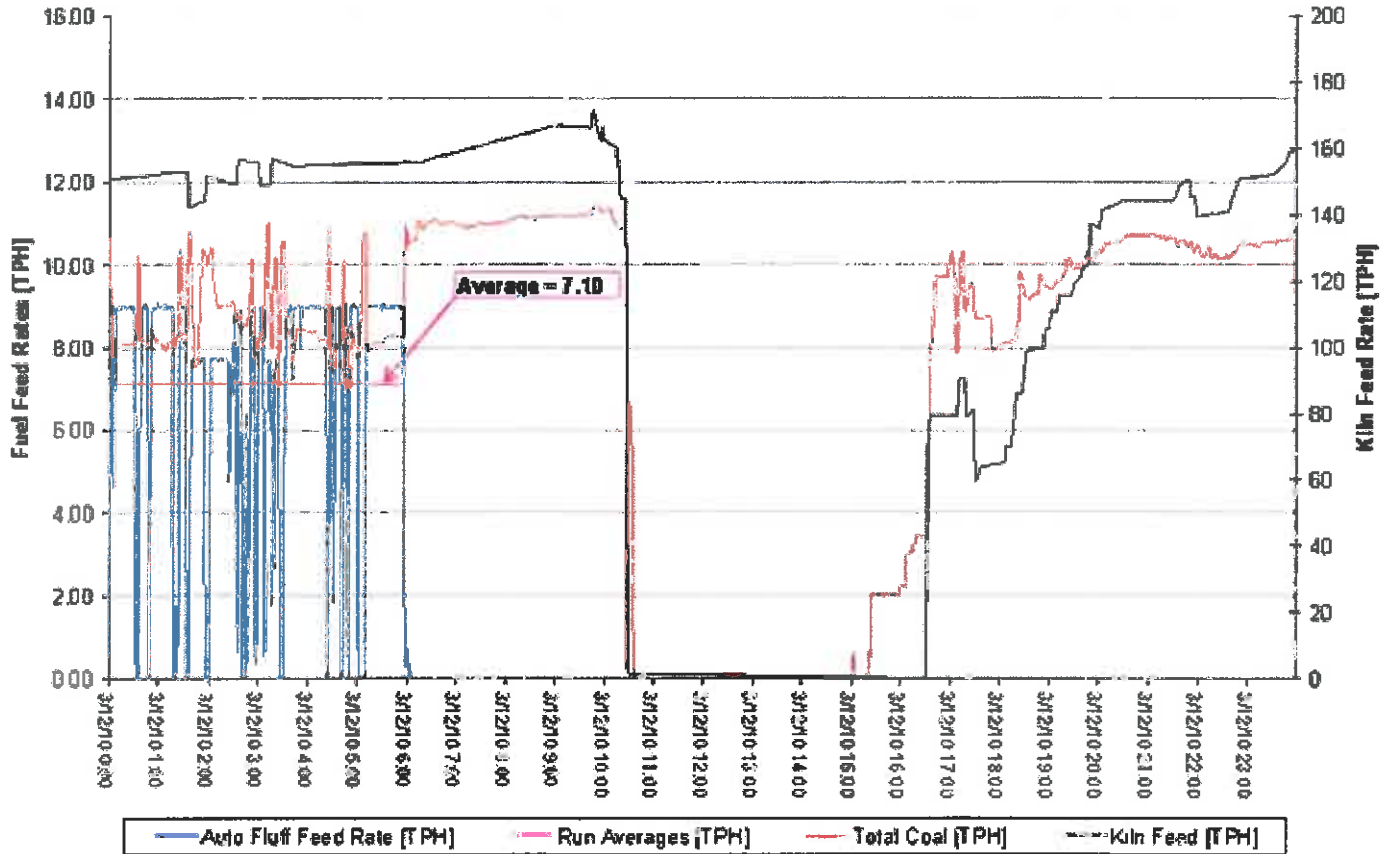
Chart 4.3 March 12, 2010 kiln feed rate, coal feed rate, and auto fluff feed rate.

SAC ran at a targeted feed rate of 9 TPH starting on March 11, 2010 (averaging 7.10 TPH including all the stops and starts) until SAC ran out of prepared auto fluff on March 12, 2010 at 6:04 AM. At approximately 10:30 AM the kiln was shut down to repair a leak on the main burner pipe. Gerdau required two more weeks to produce a sufficient amount of auto fluff (see Section 2) to restart the test trial on March 29th.

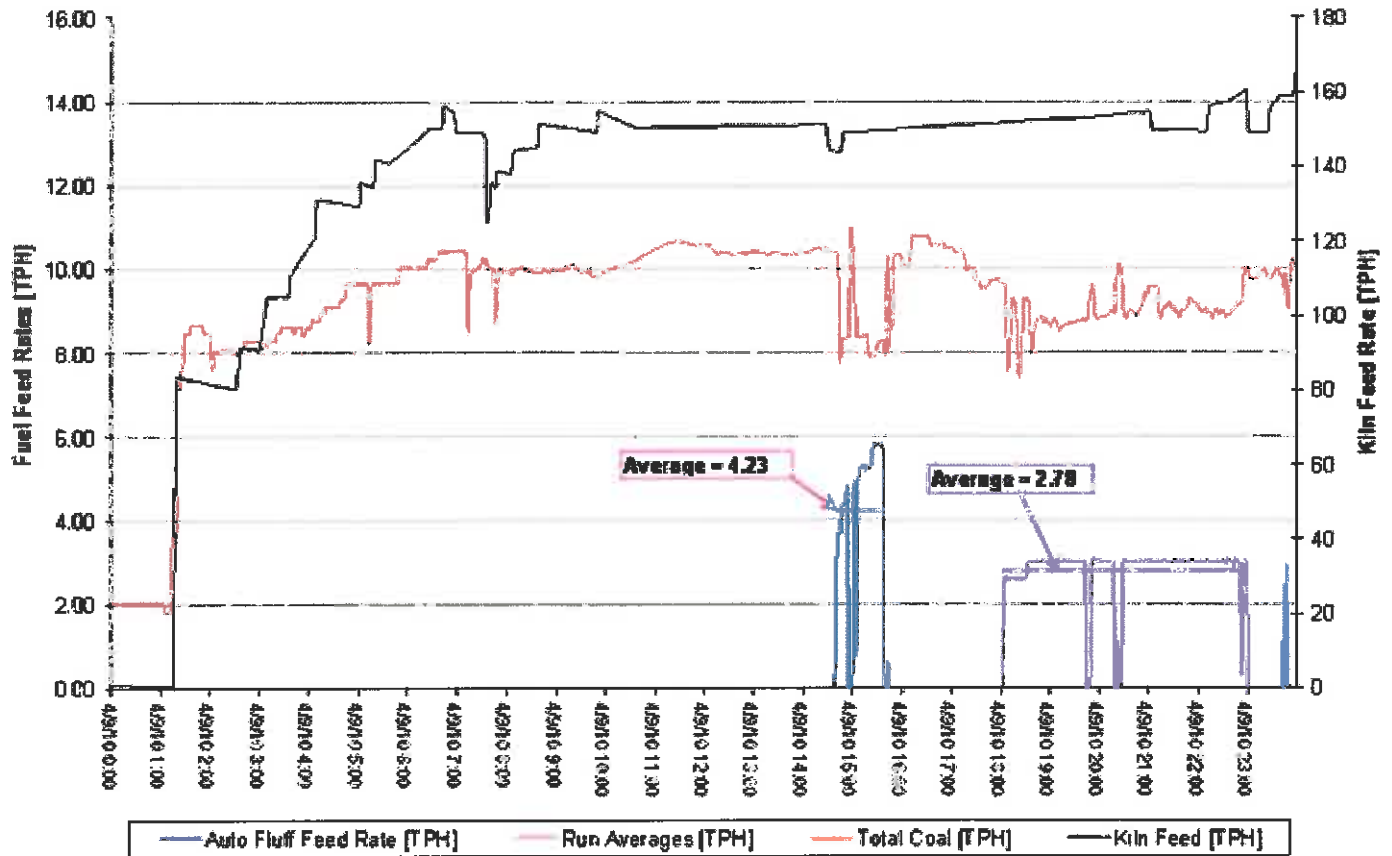
Chart 4.11 April 9, 2010 kiln feed rate, coal feed rate, and auto fluff feed rate.

April 9th was the last day of the test trial. As soon as SAC could establish stable kiln conditions, SAC began to feed material to the system at 2:40 PM. However, the feed system tripped at 3:45 PM and could not be restarted until 6:03 PM. The feeder ran until it tripped again at 10:59 PM. An attempt to restart the feeding system was made at 11:42 PM to empty out the feeding system, and the test was concluded at 11:50 PM.

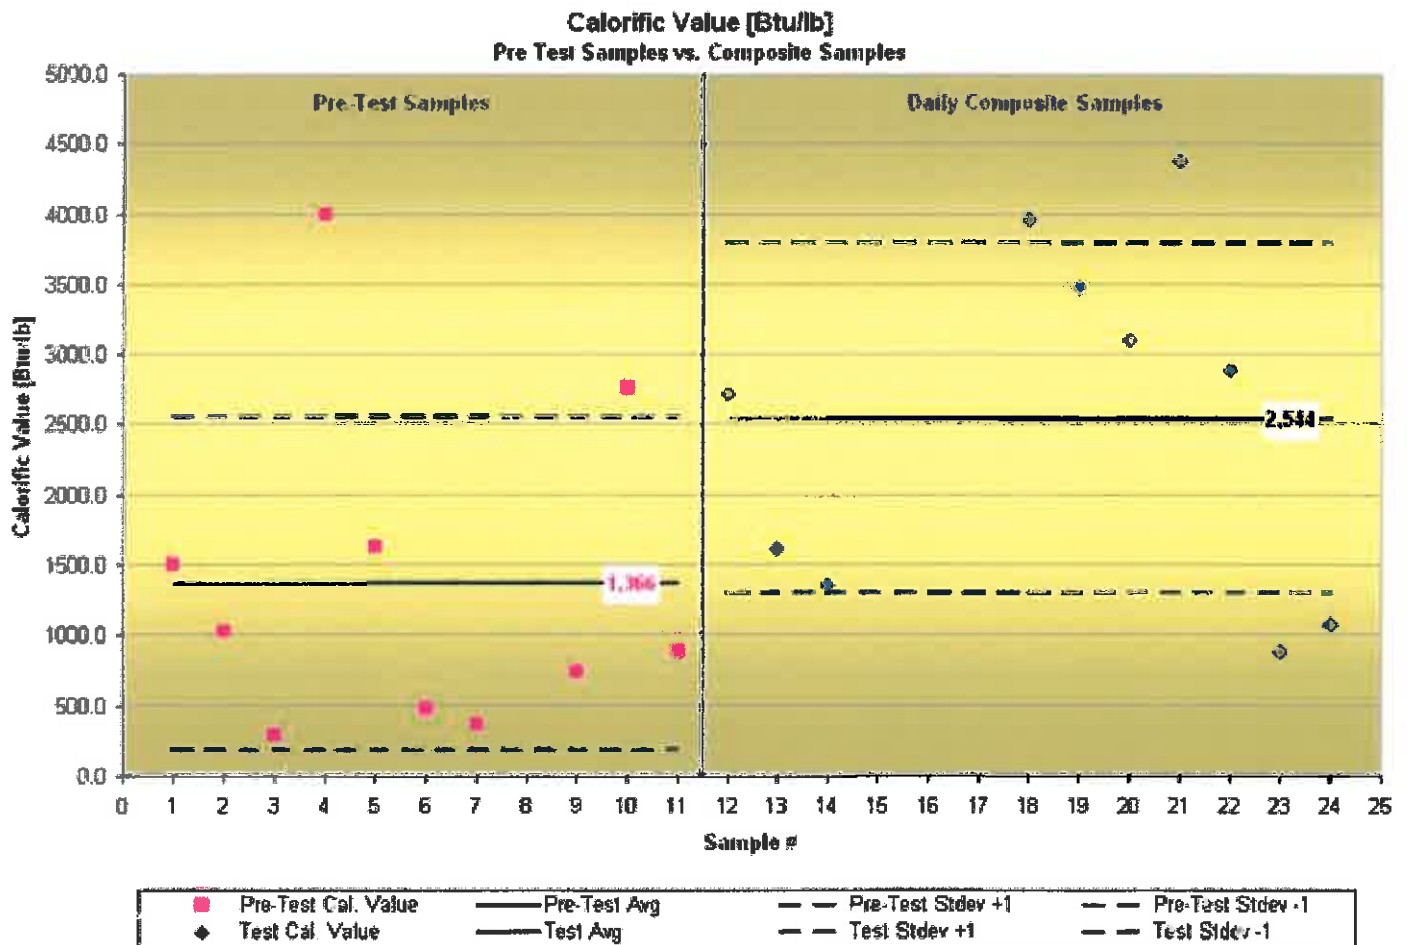
Chart 5.1 Chart of calorific value lab results of pre-test samples and daily composite samples.

The material properties summarized in Table 5.2 above, such as calorific value, ash content, and percent moisture help generally determine if the material is suitable for use as a fuel. Auto fluff consists of a multitude of materials (rubber, plastic, cloth, leather, foam, etc.) some of which are known to have significant fuel value. Therefore, the results of the analyses, showing relatively low heat content and highly variable heat content in comparison to similar analyses, including the samples analyzed for permitting. As well the results are inconsistent with auto fluff testing performed for similar permitted operations (US EPA, Oct. 2008, Draft Document). However, one variable noted during sampling was the difference of sampling location. As stated above, there are two different types of samples included in the table above; grab samples and daily composite samples of received material. Below is a chart demonstrating the difference between the lab analysis of calorific value for the pre-test grab samples and the test trial daily composite samples:

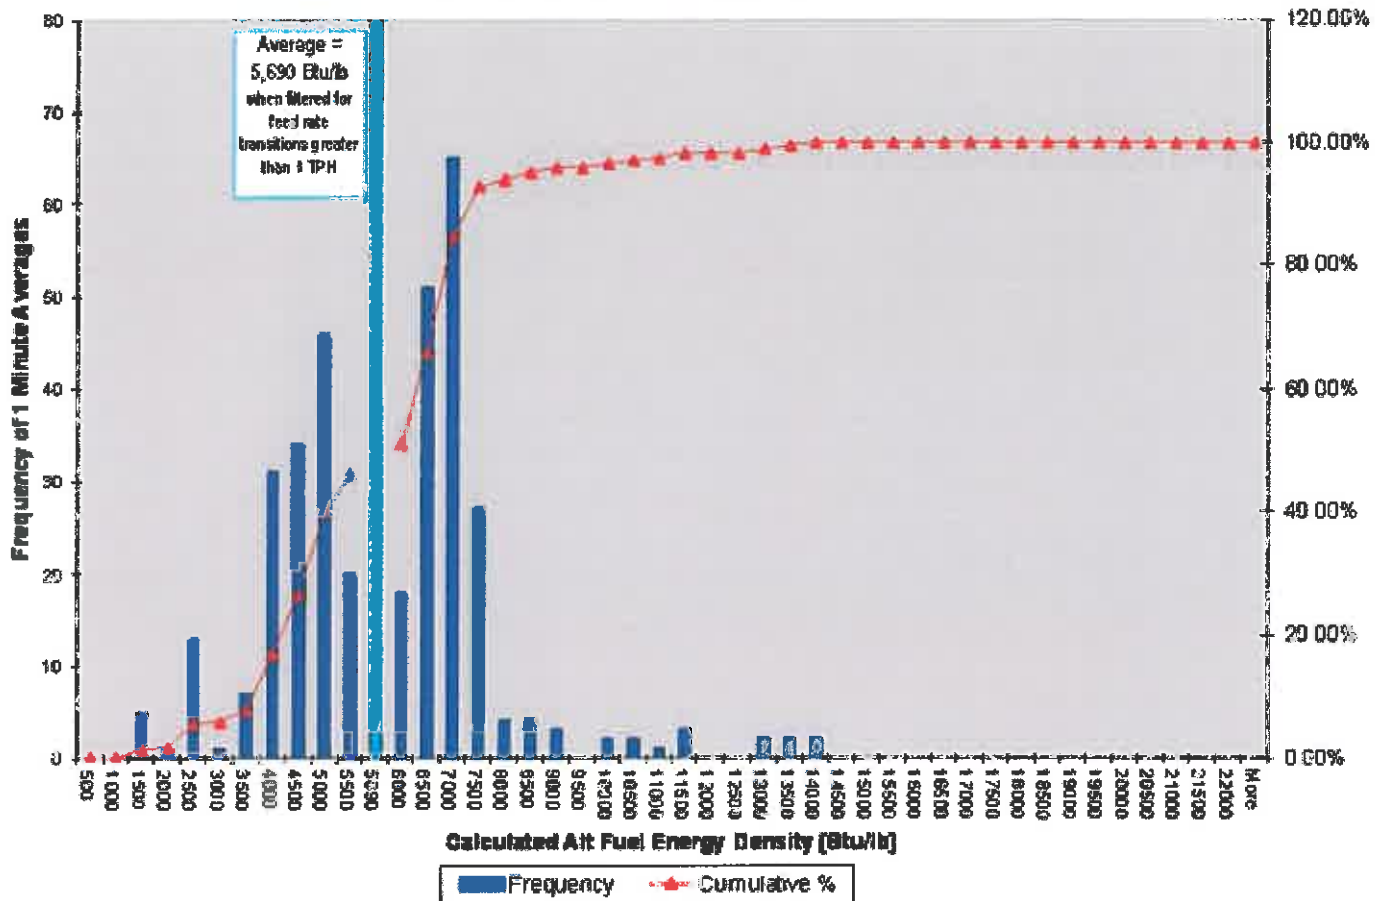
Chart 5.4 Histogram of one minute average calculated auto fluff energy density during the trial period lasting from April 8th to April 9th, 2010. The light blue line represents the arithmetic mean of all the data points as 5,690 [Btu/lb].

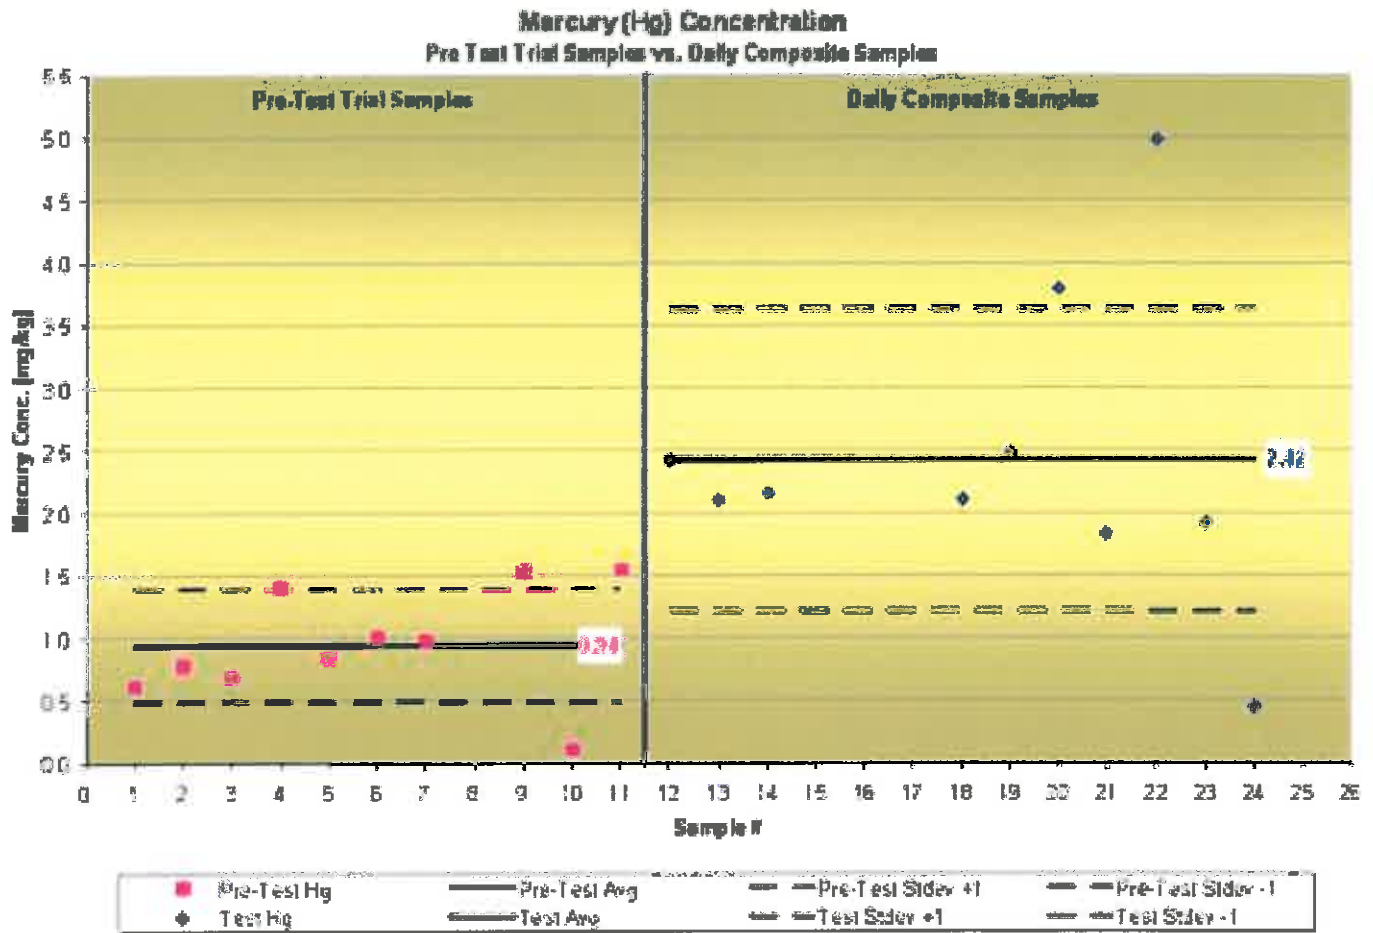
Chart 5.5 Mercury concentrations pre-test versus daily composite sample analysis.

Results displayed in the chart below were not anticipated and were surprising to all involved. Further research is necessary to determine the cause for this shift. Any further research should include increased sampling of source material as well as composite sampling of final product from the re-processing operations to determine if this change is a result of the re-processing methods, source material contamination, or laboratory preparation and analysis methodology. Future research should also provide other suppliers the opportunity to provide material for the trial. This could provide information on whether or not such contamination is an isolated issue or if it is endemic to the auto shredder industry.

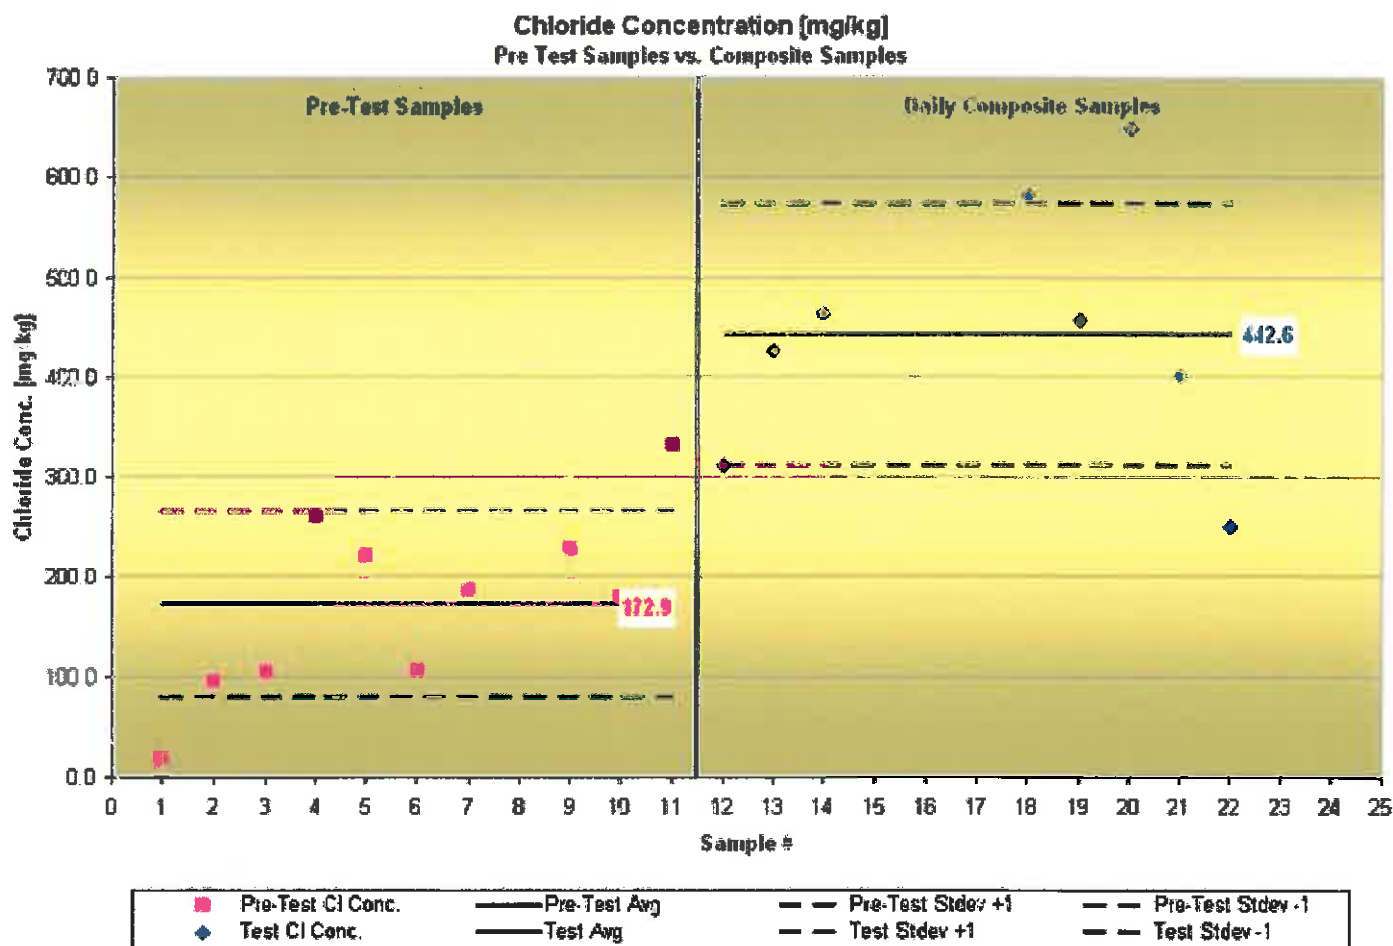
Chart 5.7 Chloride concentrations pre-test versus daily composite sample analysis.

Sulfate and fluoride concentrations were consistently low in all samples gathered. Chloride was higher, as expected, due to the presence of plastics containing chlorides. However, the concentrations are still relatively low when comparing them to results of research in other studies (Boughton, 2006). Below is a chart of pre-test and composite sample analysis:

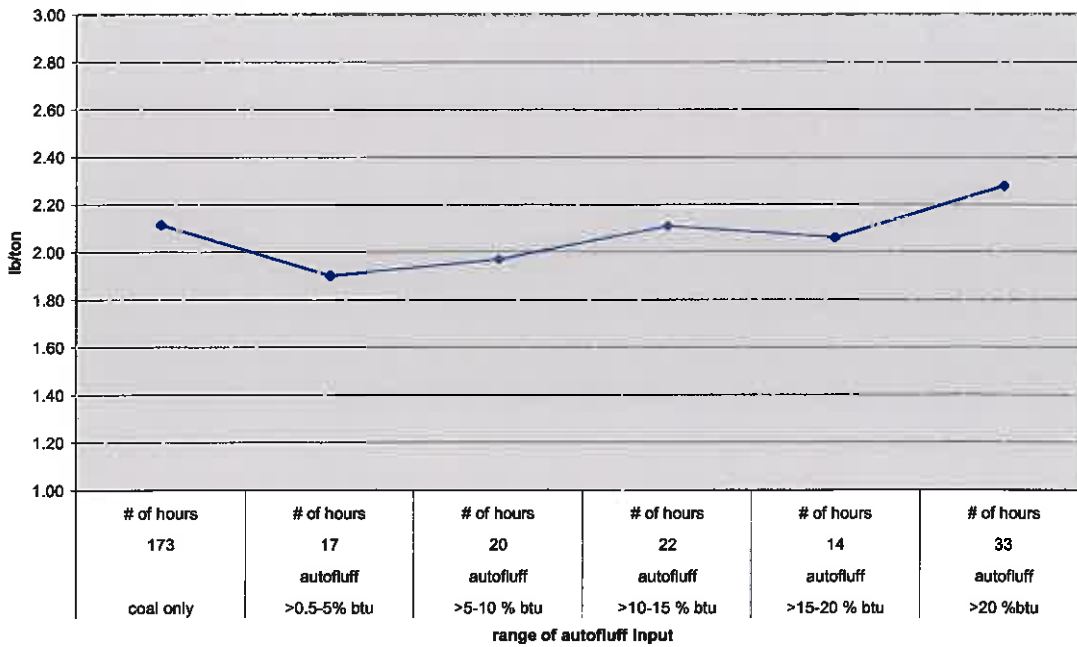
Chart 6.2 NOx emissions versus heat content of auto fluff input.

While the data is limited to 14 days of trial burns, the data do not show clear trends in emissions with increasing auto fluff input. Emissions of NOx and THC show a slight increase with concentration yet the trends are not consistent with increased auto fluff input. The limited amount of hourly data makes assessment of the possible trends of emissions questionable. Furthermore, NOx is controlled by SNCR so any potential trend of NOx is a function of the SNCR system. All emissions and opacity were in compliance during the trial burns.

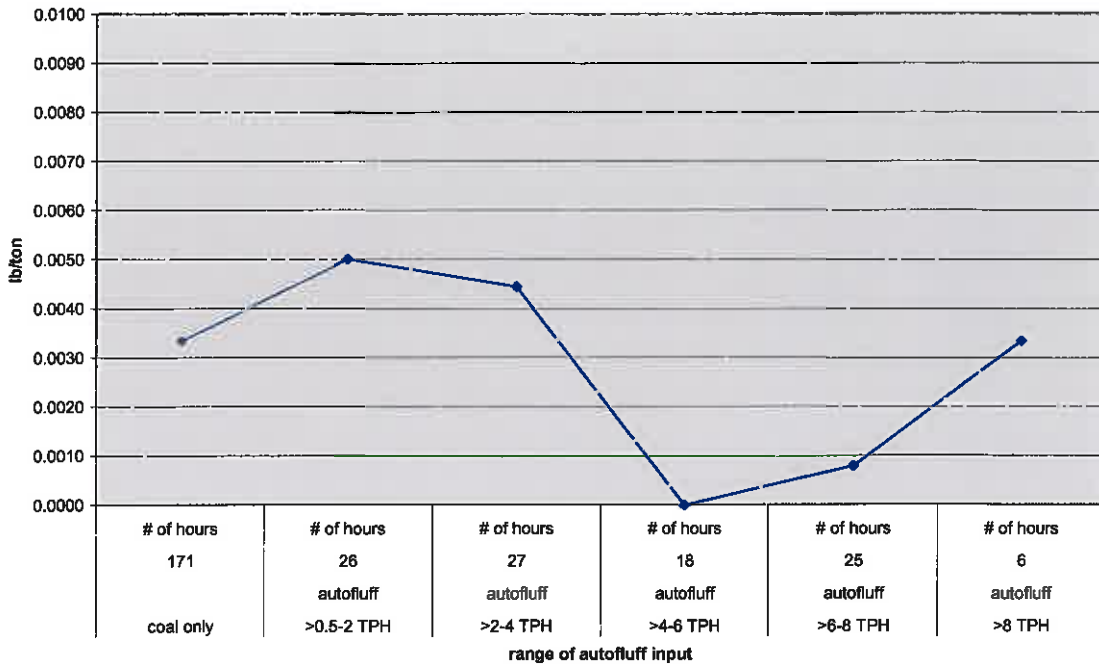
Chart 6.3 SO2 emissions versus tonnage of auto fluff input.

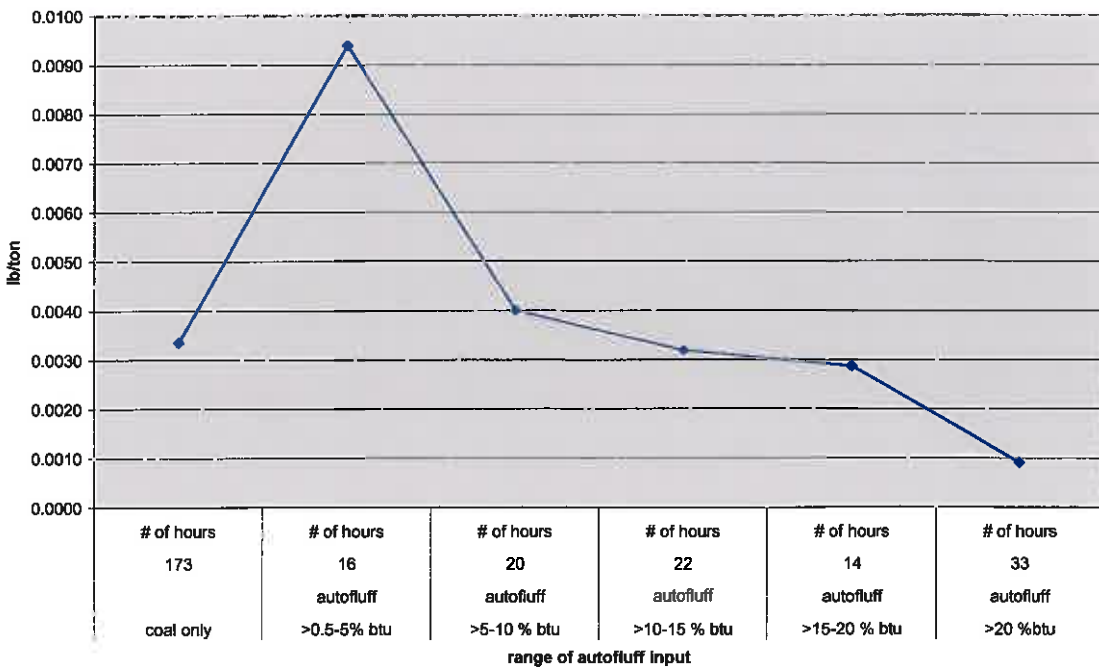
Chart 6.4 SO2 emissions versus heat content of auto fluff input.
